DUTCH SAFETY BOARD

MH17 Crash

Investigation into the crash of flight MH17

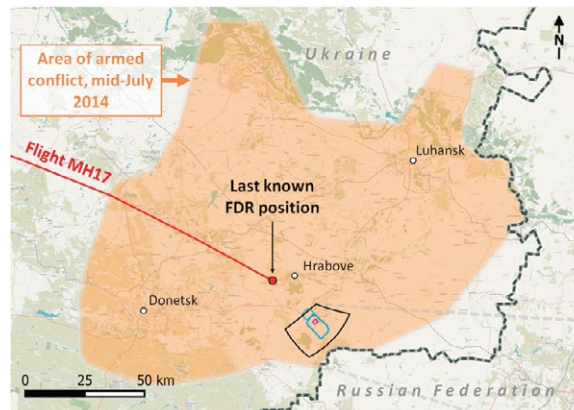
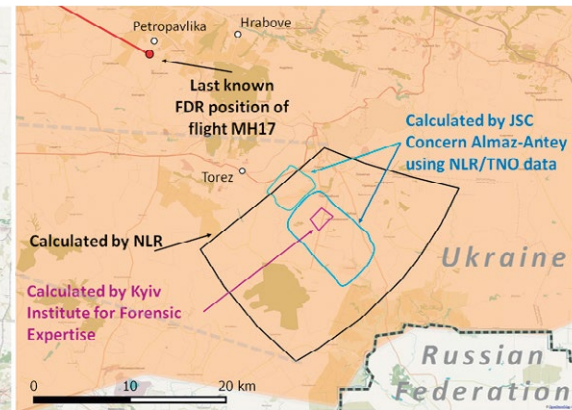
Combination sketch of the calculated areas. The Russian Federation, at the Dutch Safety Board's request, calculated a possible launch area without confirming the use of a 9N314M warhead, a 9M38-series missile or a Buk surface-to-air missile system. (Source: Dutch Safety Board)

It is not possible to determine the exact position and angle from which the missile was fired, the speed at which this occurred and the local circumstances at that moment. Based on the impact pattern, the impact angle and other data a calculation was made to determine the missile's trajectory, which originated in an area spanning approximately 320 square kilometres in the eastern part of Ukraine.

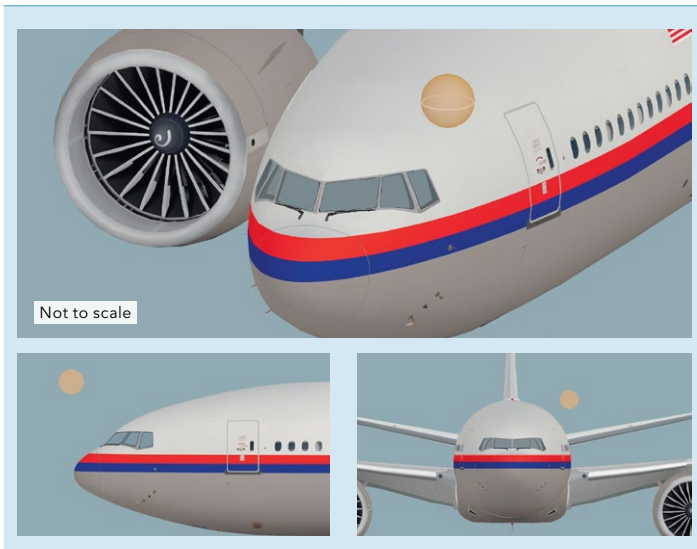
The recording on the Cockpit Voice Recorder ended abruptly at 13.20:03. A high-energetic sound wave lasting 2.3 milliseconds was detected in the final 20 milliseconds of the recording. This sound wave originated from outside the aeroplane, above the upper left-hand side of the cockpit. This is consistent with the position of the warhead at the moment of the explosion.

Simplified representation of the volume of space of the warhead detonation location according to three independent simulations (Source: Dutch Safety Board)

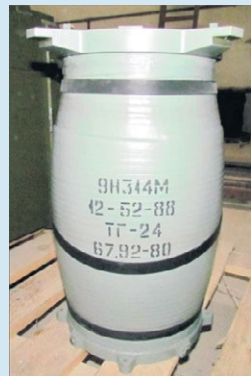
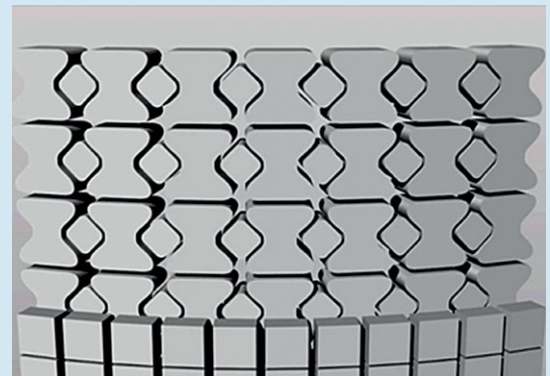
The particles found in the aeroplane and in the bodies of three of the crew members consisted of unalloyed steel. The particles are cube and bow-tie shaped. The number of impacts, the distribution pattern and the shape of the high-energy objects that were found are consistent with the pre-shaped fragments in the warhead of the 9N314M model.

Left: example of a 9N314M-warhead. Middle: The different shaped particles in the warhead. Right: 3D-print of the arrangement of the pre-formed particles.

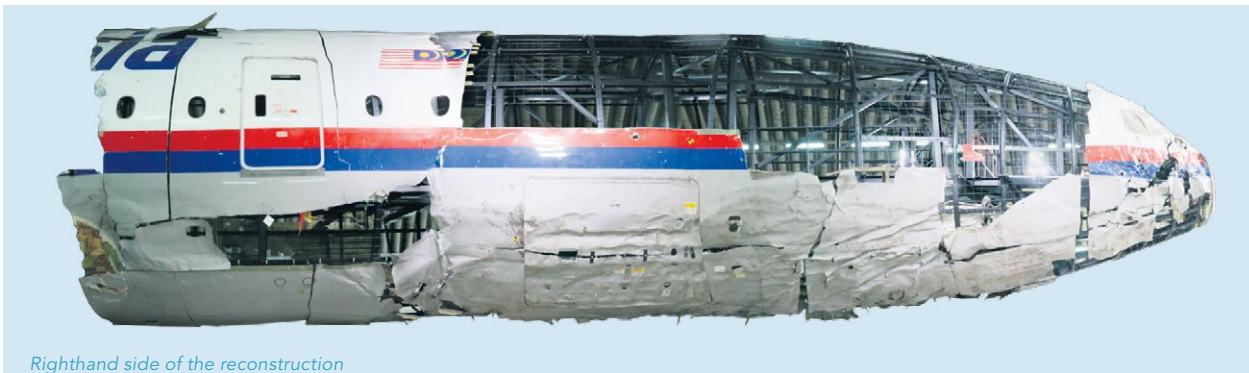
Righthand side of the reconstruction

The reconstruction shows the consequences of the impact on the aircraft, the angle at which the cockpit was hit and the manner in which the aircraft subsequently broke up.

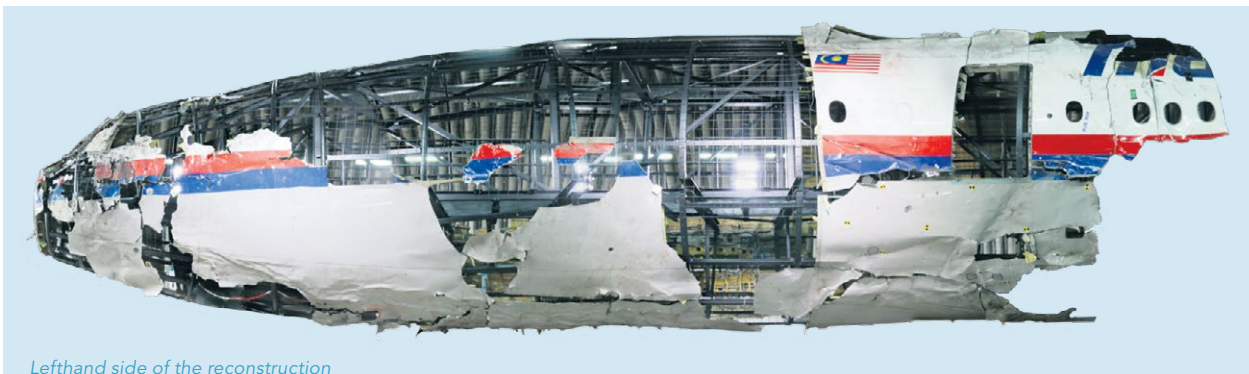
Lefthand side of the reconstruction

The investigation revealed that the missile approached the aircraft almost head-on, in the direction of the upper left-hand side of the aeroplane. The warhead exploded to the left of the cockpit. This is evident from the aeroplane's damage pattern, which shows the highest number of impacts on the left-hand side of the cockpit.

This reconstructed section of the cockpit clearly shows the impacts of the high-energy objects. Examination of the impact pattern demonstrated that the warhead detonated on the left side, just above the cockpit, and that the particles spread out in a characteristic pattern and penetrated the aeroplane.

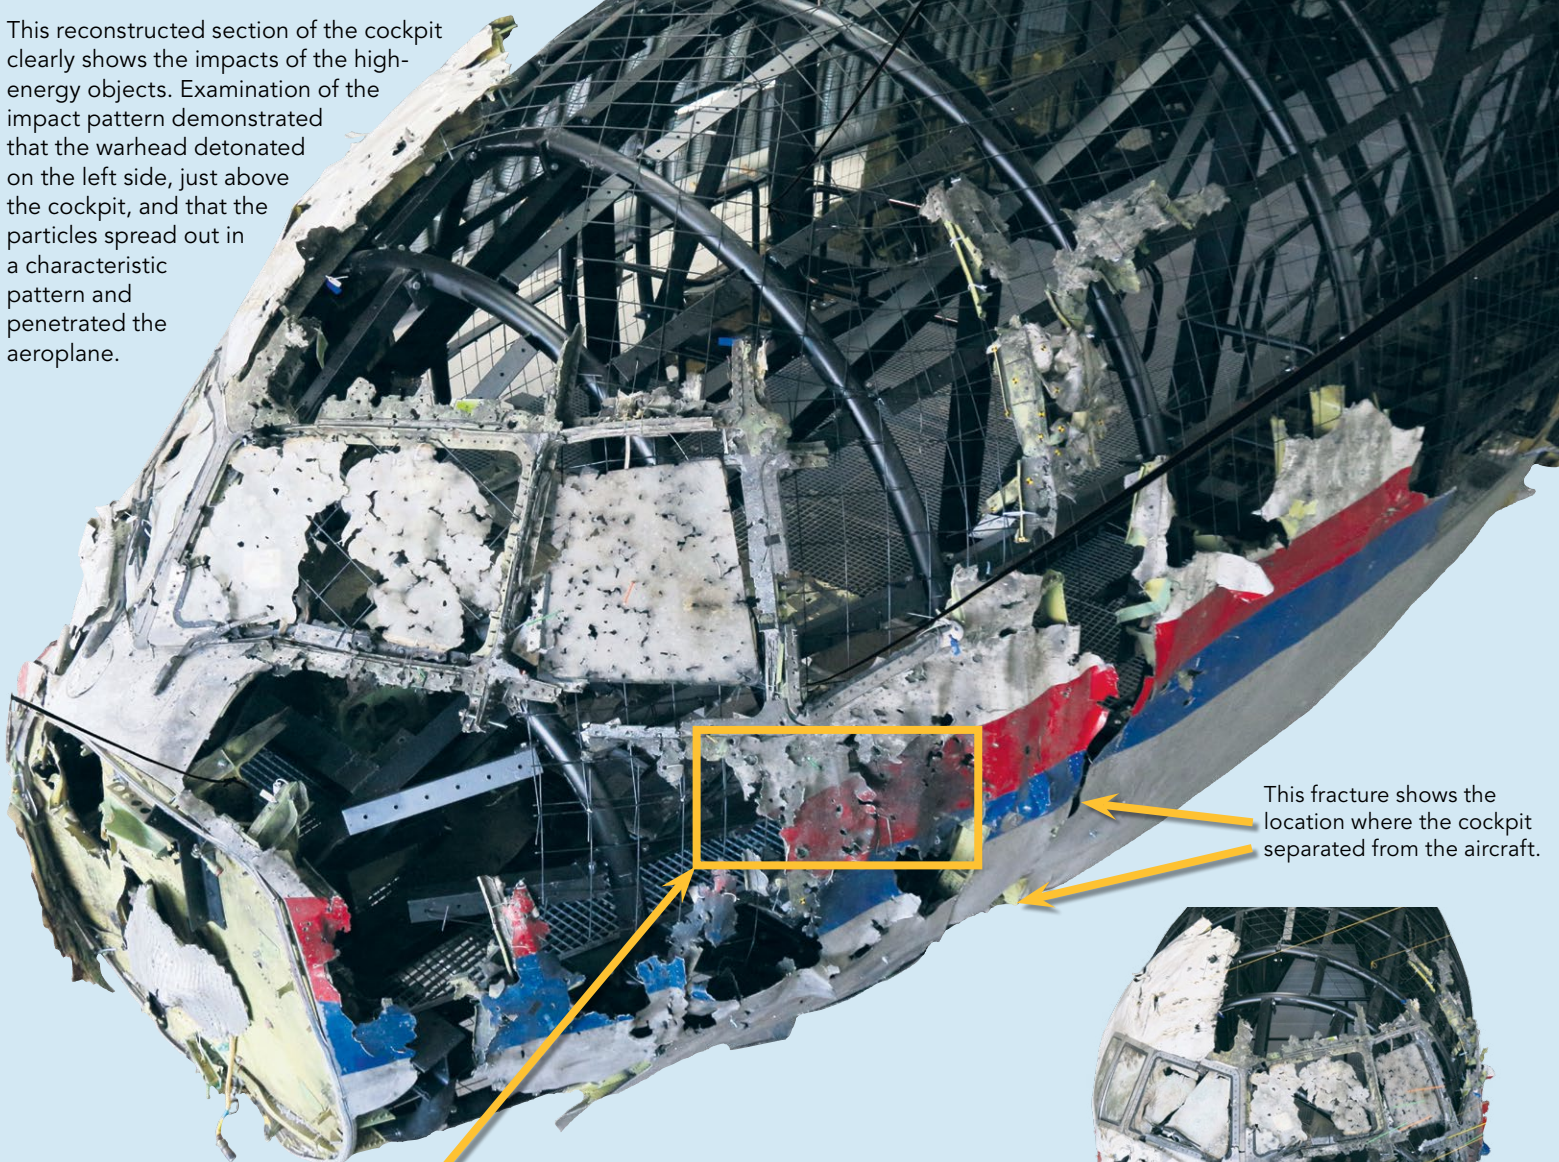
This fracture shows the location where the cockpit separated from the aircraft.
